# **The UTS Durability Test for Earth Wall Construction.**

**Dr. Kevan Heathcote & Gregory Moor**

**University of Technology Sydney**

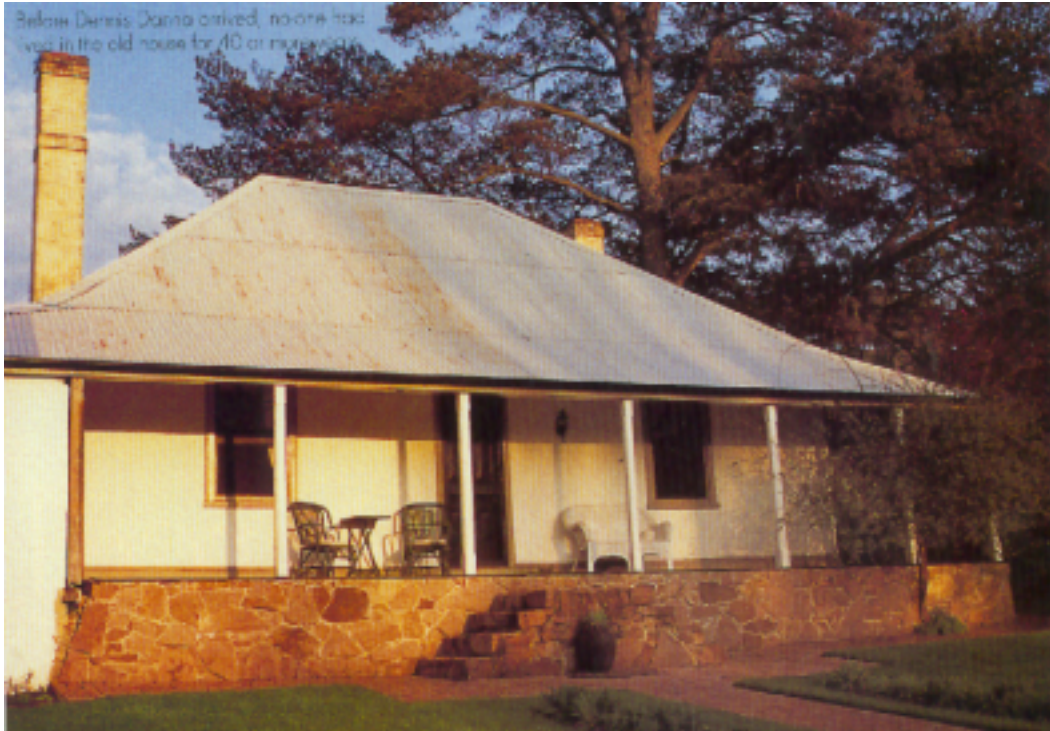
**Figure 1**     **Pise' house near Bathurst c1850.**  
(note the wide roof overhang and rendered walls)

constructions and of temporary nature. There are no remaining earth buildings before the mid nineteenth century, however we have written reference to the use of earth wall construction during this early period of settlement. The first European settlers who arrived in Sydney Cove were not aware of Aboriginal construction methods but soon found the small acacia trees were suitable for wattling and plastering with clay. The trees became known as wattles and the building process wattle and daub. Governor Philip began a new settlement at Parramatta and before the end of 1790 there were thirty-two houses completed, built of wattles, plastered with clay and thatched. Termites, rain and increasing property development led to the destruction of all early earth wall buildings in Sydney. The earliest remaining earth buildings are from the mid nineteenth century and are all located in rural areas far from the city. It should be noted that these remaining buildings have well maintained surface coatings as well as wide roof overhangs (Figure 1)

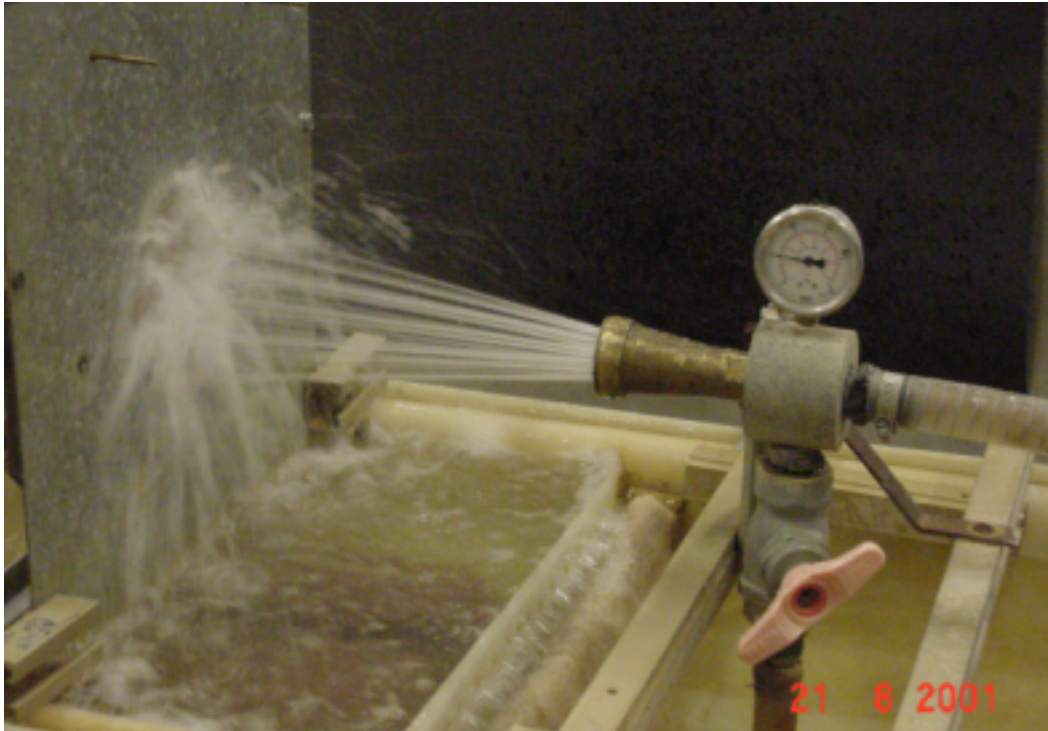
**Figure 4      Bulletin 5 Accelerated Erosion Test**

In response to an increased interest in earth construction in the 70's the Commonwealth Experimental Building Station in Australia developed an accelerated erosion test based on spraying water horizontally onto specimens using a specific nozzle (Schneider, 1981). This test is referred to as the “Bulletin 5” accelerated erosion test (Figures 3 & 4) as that is the name of the document in which it is contained.

The test consists of spraying the face of a sample for a period of one hour or until the sample is penetrated. The test is interrupted at fifteen-minute intervals and the depth of erosion measured with a 10mm diameter flat-ended rod. The total depth after one hour is divided by sixty to give erosion in mm per minute. The maximum permissible erosion rate for all types of earth construction is one mm per minute.

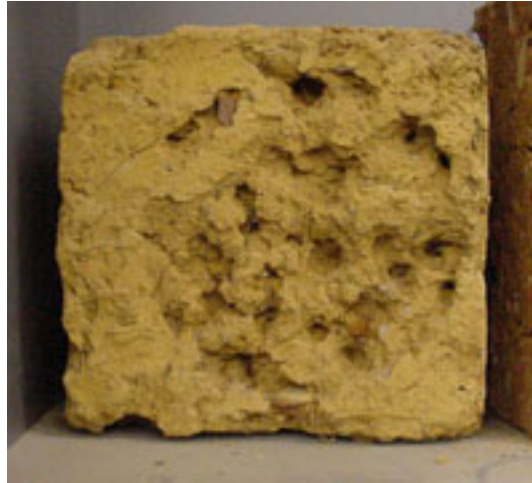
**Figure 5 Earth Block showing erosion created by Bulletin 5 Test**

Two general difficulties in using the Bulletin 5 test to predict earth wall performance became obvious to the authors. The first is that the test does not in any way simulate rainfall and as can be seen in Figure 5 actually bores

holes in the specimens. Secondly in interpreting the results of the test no consideration is given to the climatic conditions in which a proposed building is to be located.

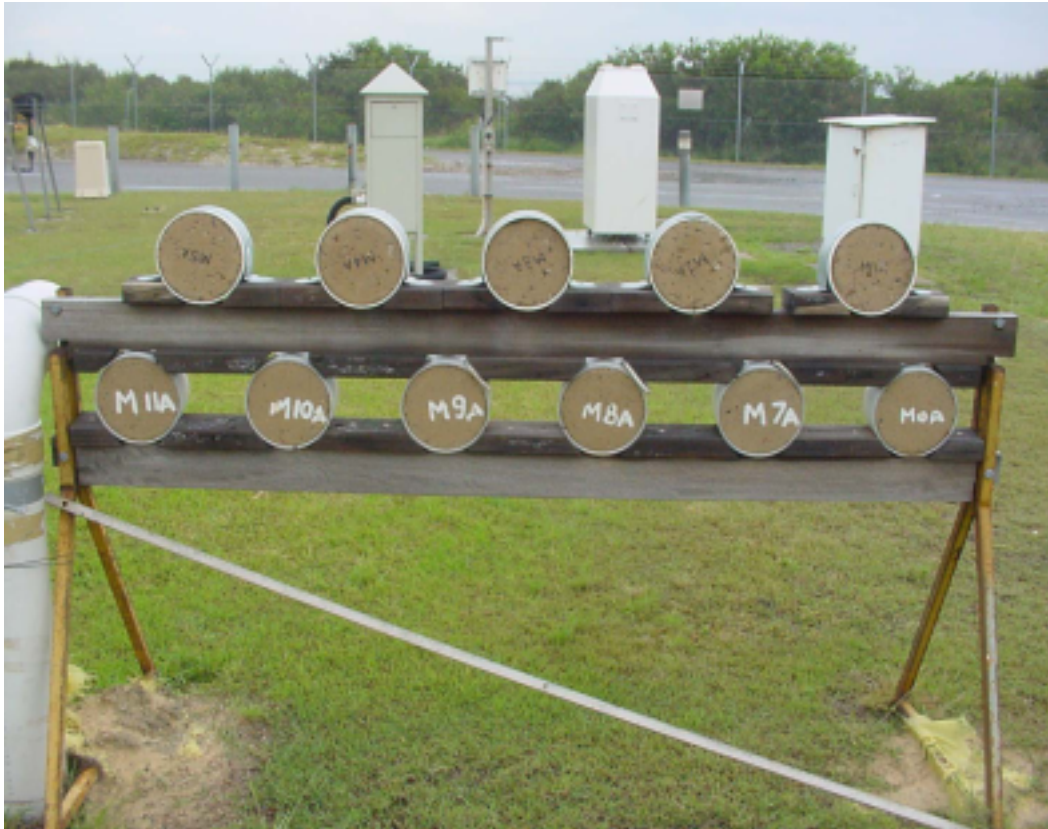
**Figure 8      Specimens being Field Tested at Weather Station**

A testing procedure was developed where the one specimen was tested in the laboratory and then in the field. The field-testing was done at a weather station where wind and rainfall data was available. From previous experience it was noted that wind driven rain predominantly came from the south and therefore the specimens were faced in a north/south orientation to receive maximum exposure. To simulate wall construction the edges were protected from the weather by a PVC tube (Figure 8).

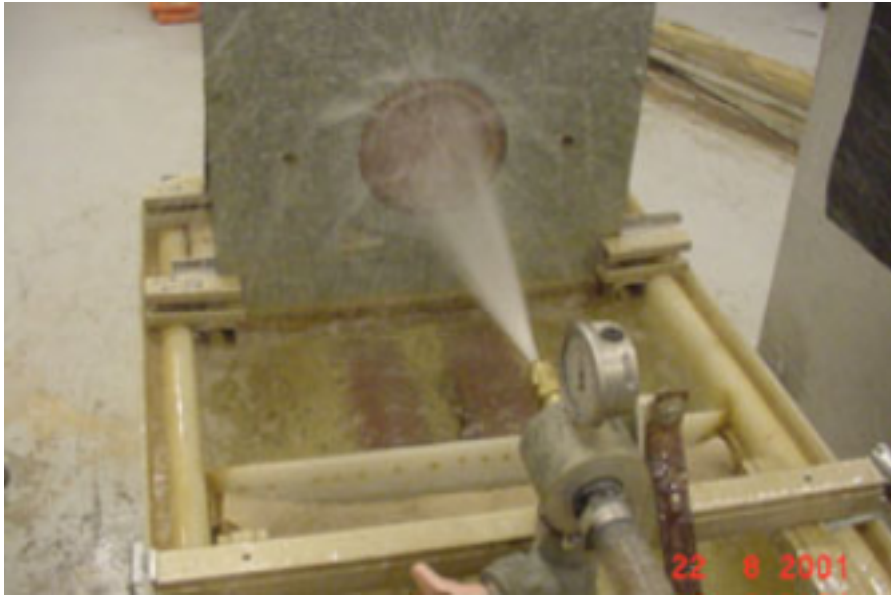
## Figure 10 UTS Accelerated Erosion Test

Details of the setup of the UTS spray test are given in Figure 9. Figure 10 shows a specimen being tested at UTS.

In the test specimens are placed with their external face surface exposed to the spray, which impacts the specimens through a 100 mm diameter hole. A Fulljet 1550 nozzle is positioned 350 mm from the face and water is sprayed at a pressure of 70 kPa. The runoff water is filtered before being re-cycled.
